EVALUATION OF MODIFICATIONS OF AM2 AND
XM18 LANDING MAT

C. D. Burns, et al

Army Engineer Waterways Experiment Station
Vicksburg, Mississippi

MISCELLANEOUS PAPER S-70-5

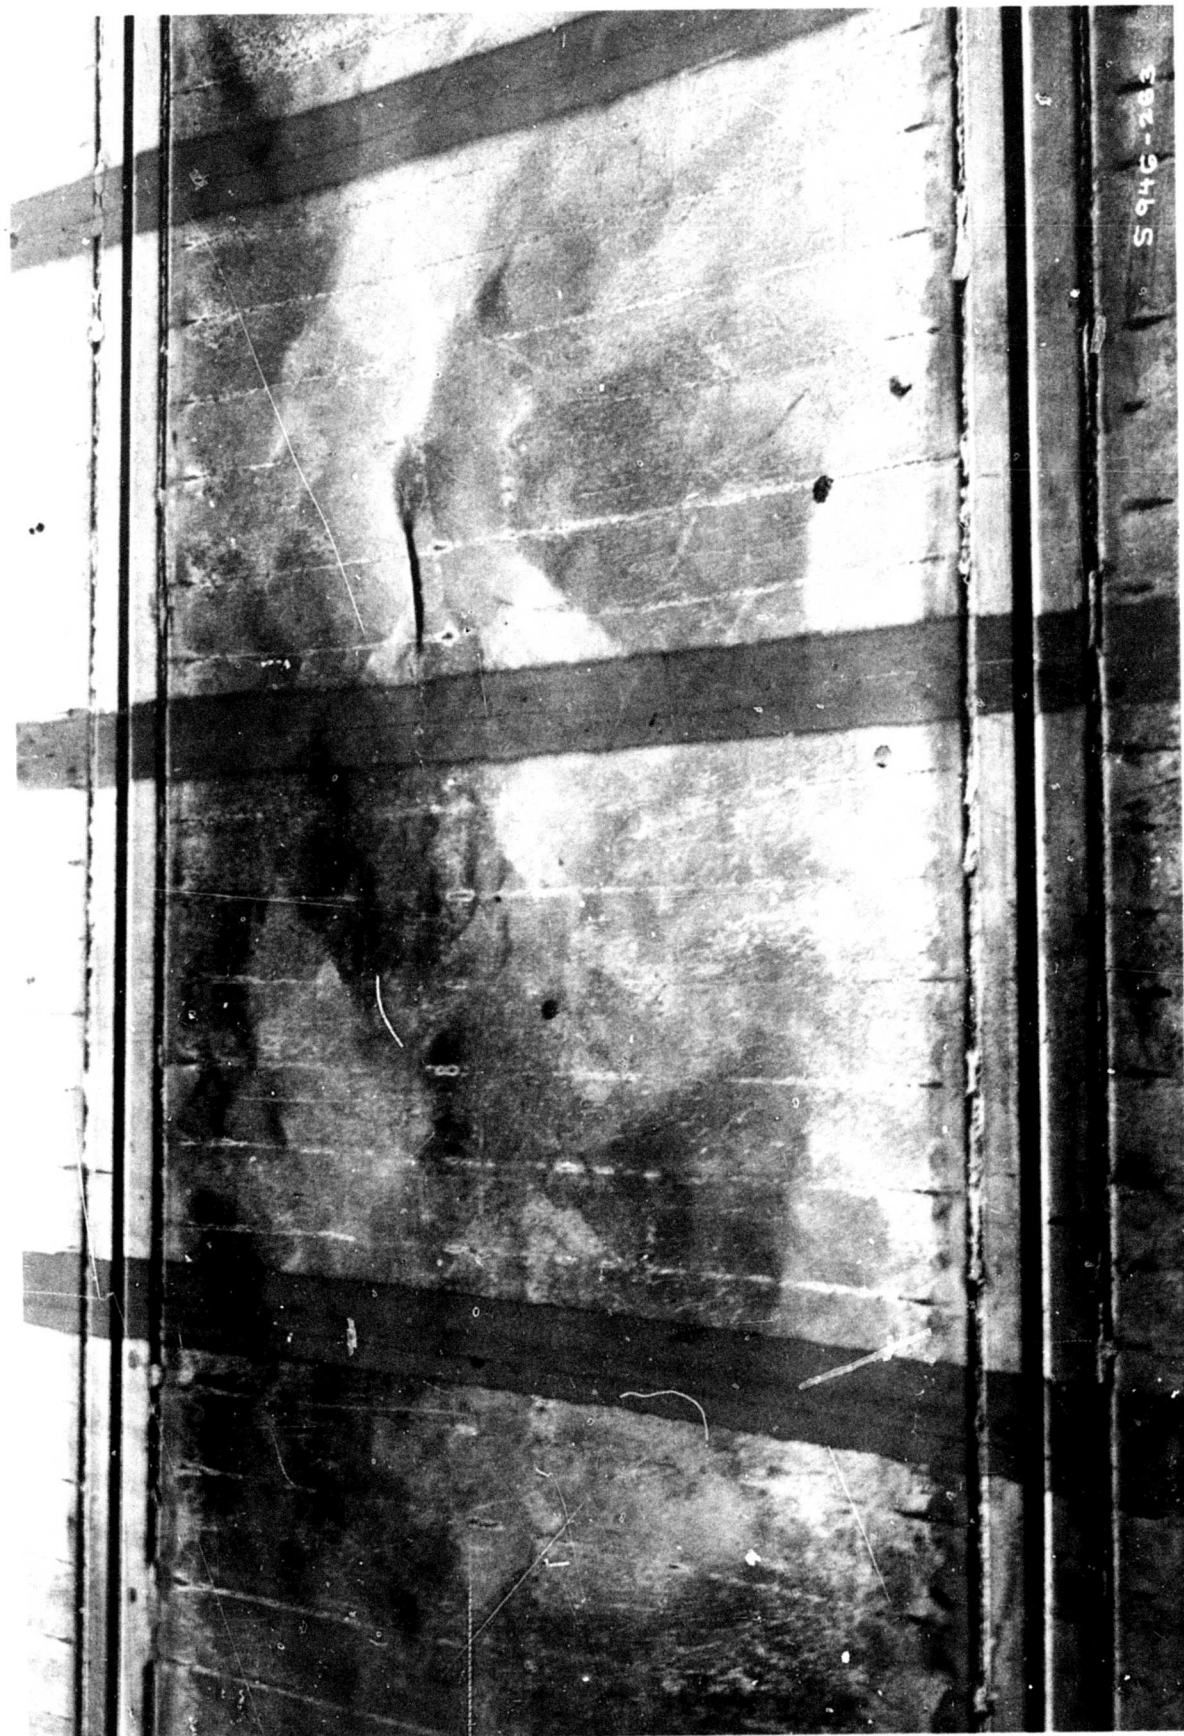
Photograph 4. AM2 mat panel 6 after failure at six coverages

19. Item 1, Alcoa AM2. A general view of item 1 prior to traffic is shown in photograph 2. Dishing of 5/8 in., as shown in photograph 3, was observed in panel 6 on the first pass of the load cart. After six coverages, the dishing had become so severe that the panel was considered failed. By six coverages, panels 20 and 27 had also failed in a similar manner, and the three panels were replaced. Photographs 4 and 5 show, respectively, panel 6 at failure before removal from the test item and the damaged core after removal.

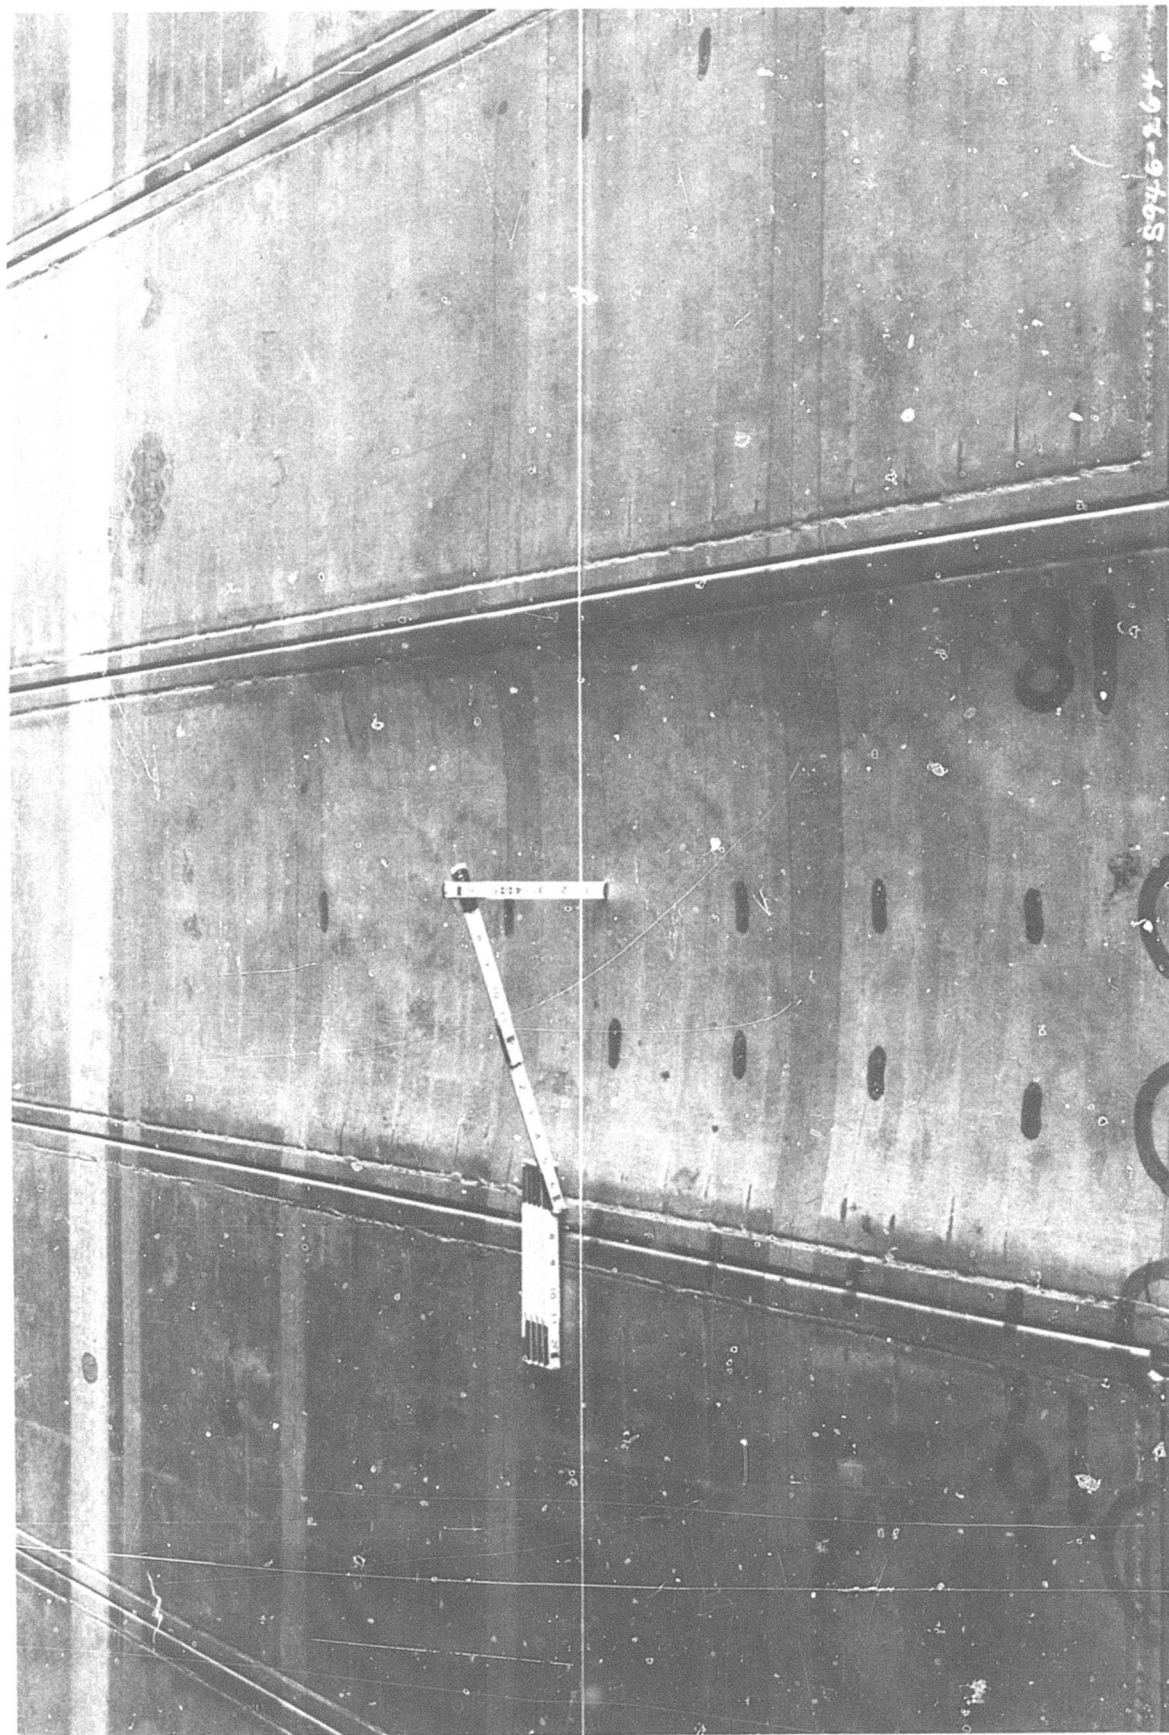
Photograph 6. Dishing of 1-1/8 in. observed in AM2 panel 18 at failure after 36 coverages

20. After 16 coverages, end-joint weld cracks averaging about 1/2 in. in length were observed in three panels. All the weld cracks originated at the C-rail corner. After 28 coverages, dishing had developed in panels 9, 18, and 30, and by 36 coverages, panel 18 was

considered failed and was replaced (see photograph 6). By 72 coverages, dishing had become so severe in several more panels that traffic was stopped and item 1 was considered failed. A total of eight panels had failed due to severe dishing throughout the period of traffic. An overall view of item 1 at failure is shown in photograph 7.

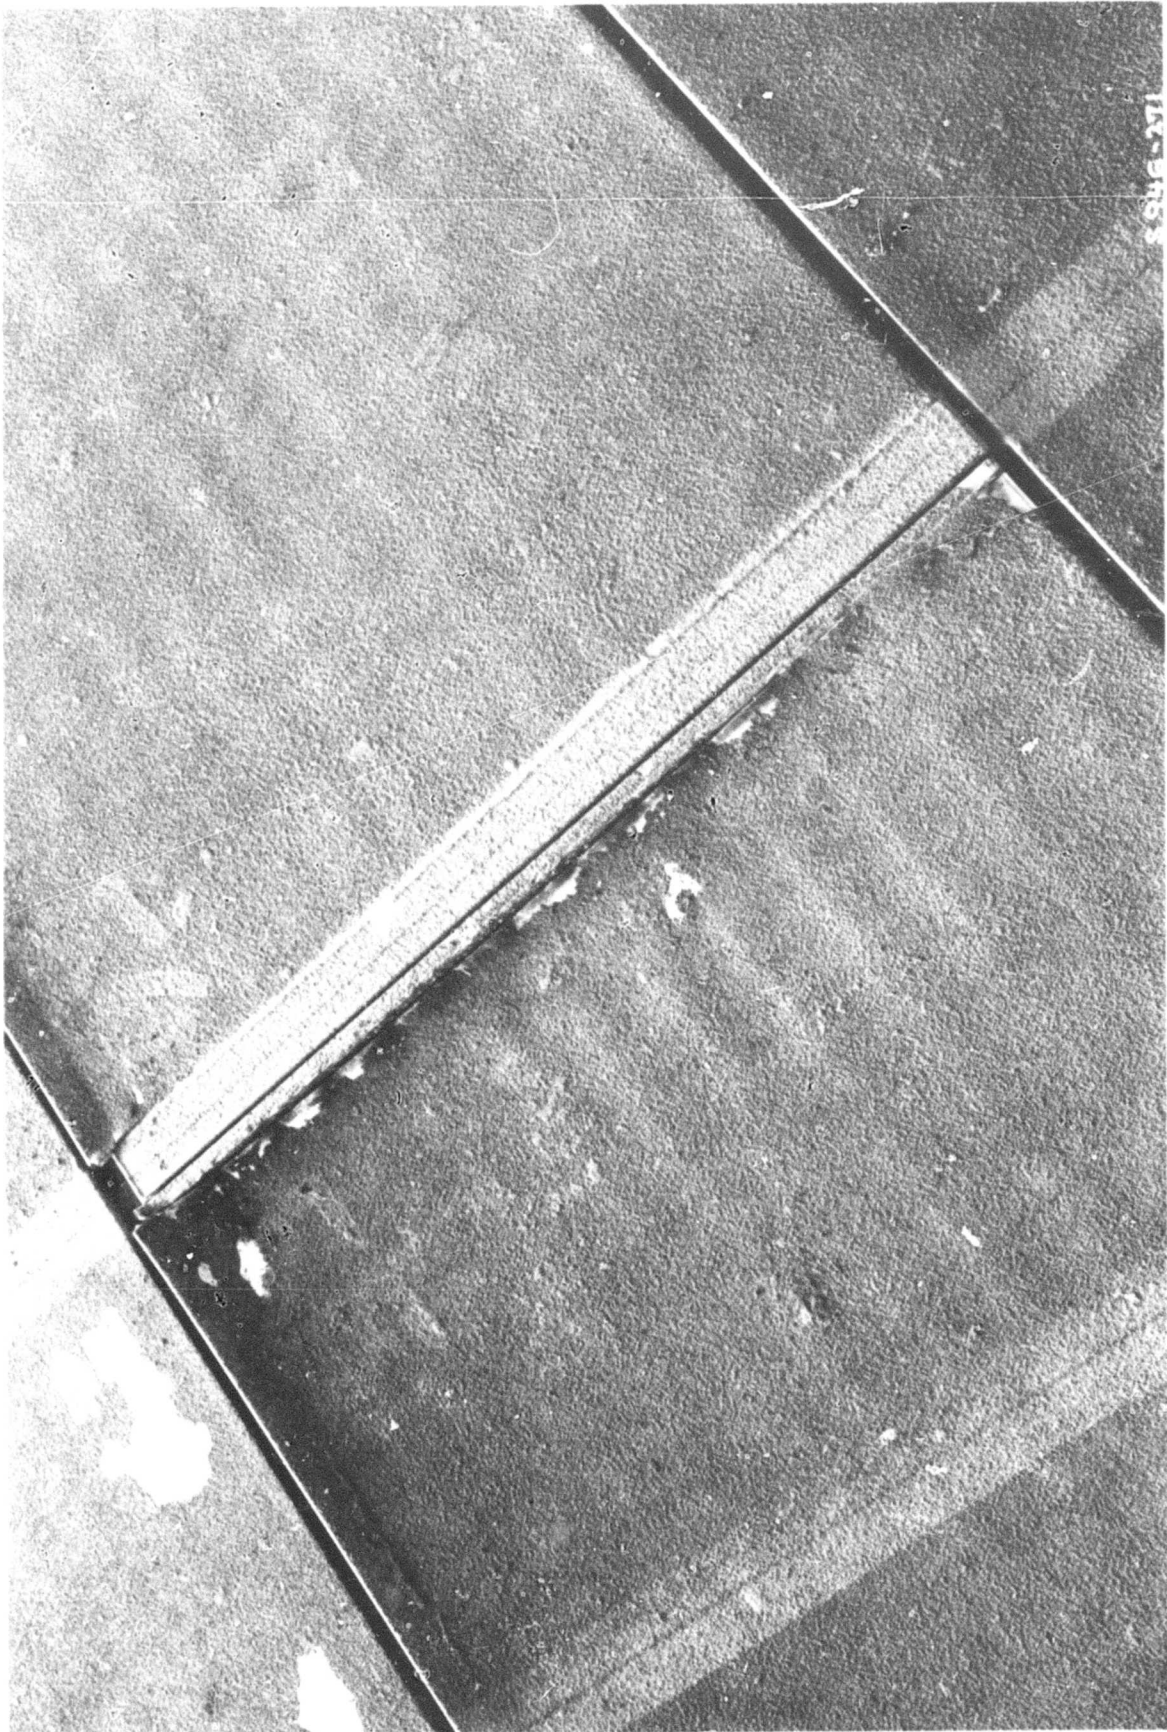
Photograph 10. Weld break along underlapping end joint of XM18 mat panel 55 after 78 coverages

29. Test item 2 (XM18) supported 188 coverages of traffic before failure. Weld cracks along the end joints were first observed after 16 coverages, and by 78 coverages, the end joint of one panel had completely sheared off due to weld failure. An examination of the panel after removal from the test section (photograph 11) revealed that the electron beam weld had not penetrated the thickness of the mat on several of the vertical ribs. With increased traffic, top skin tears began to develop at right angles to the weld breaks, and by 188 coverages, item 2 had failed due to excessive mat breakage. Soil strength of the subgrade for item 2 during the period of traffic was rated at 4.3 CBR.
